MARITIME HERITAGE MINNESOTA

Ann Merriman
Christopher Olson

Andy Gibson Starboard Gunwale and Deck Excavation

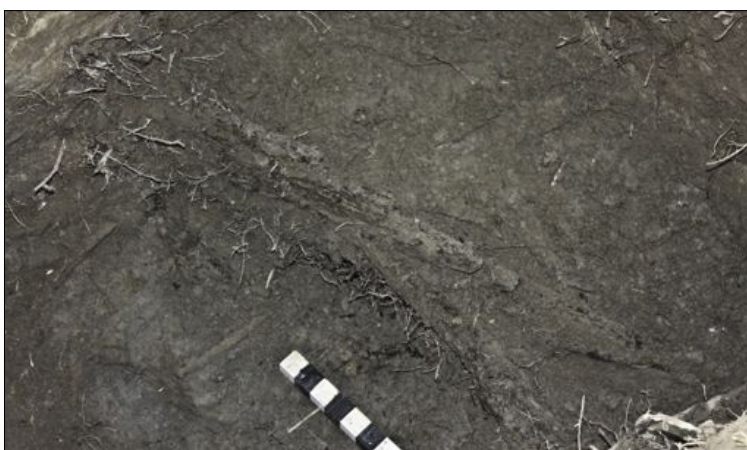
On 15 September 2011, MHM opened a new trench, Trench 4, 20 forward (upriver) from Trench 3. The reason for sinking the trench was to locate the turn of the bow and to determine the condition of the gunwale near the bow. Iron fasteners and one deck plank were encountered in the matrix and one outer hull plank was discovered in place, angled so as to suggest the angle of the turn of the bow. The trench was recorded, photographed, and back-filled.

Hull plank angled to suggest the turn of the bow in Trench 4.

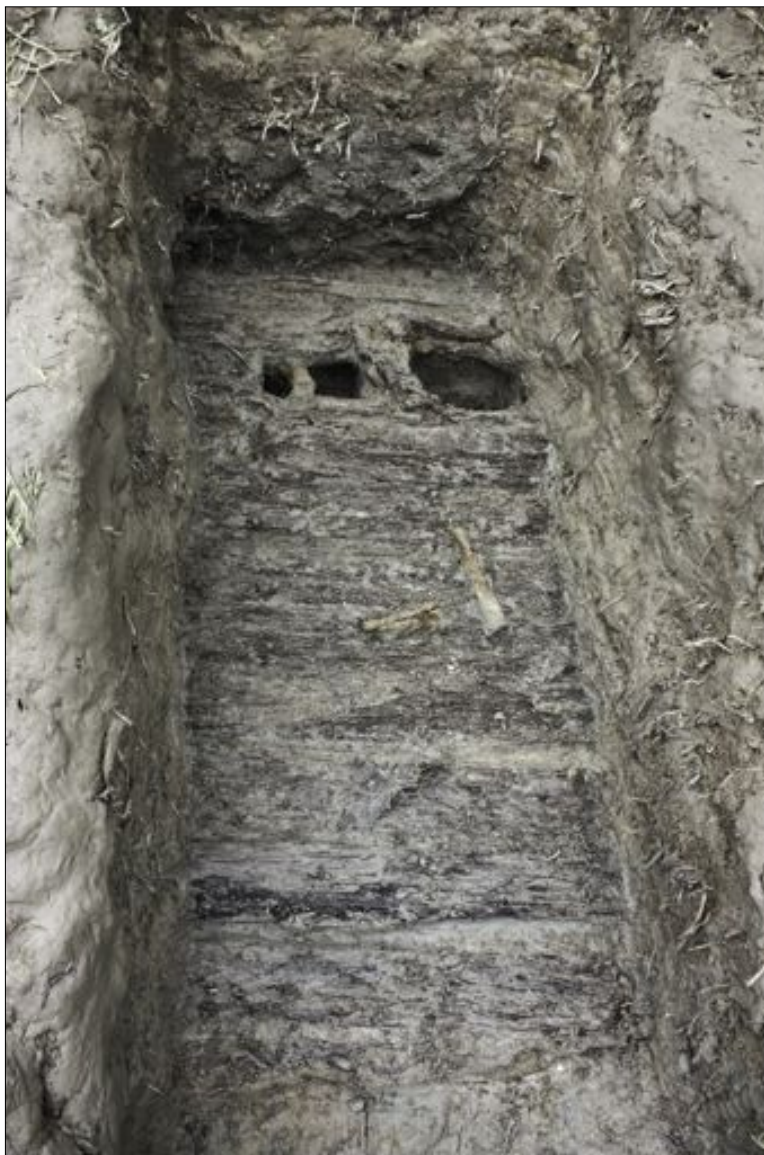
Trench 2 was originally excavated between 18 and 24 October 2010 during high water conditions. Even though the entirety of the starboard gunwale is imbedded in the riverbank and several feet below the surface, it does become water soaked periodically depending on the river water level. Unexpected low water conditions allowed MHM to re-open the trench on 16 September 2011 in order to more fully investigate the inner hull structural components that could not be accessed and documented in 2010. The shifting of deck planks at the gunwale allowed the clearing of the area between the inner outer hull and the clamp and down toward the turn of the bilge. Also uncovered were 8 intact deck planks *in situ*, although the deck beams underneath them had collapsed. It is apparent that most of the wreck's starboard side is intact from the bottom hull planks to the gunwale and decking. The intact nature of the deck planking prevented MHM from clearing a large area between the clamp and outer hull, but there was enough space to determine the placement of the futtocks and cocked hat. The trench was photographed, drawn, and back-filled.

Trench 2. These 8 intact deck planks *in situ* are unique and relatively stable. MHM cleaned out the area between the inner outer hull and the deck planks because one deck plank was missing. Limited working space did not allow MHM to reach the turn of the bilge in this trench. The clamp, futtocks, and cocked hats were located. Note the two metal fasteners loose on the deck.

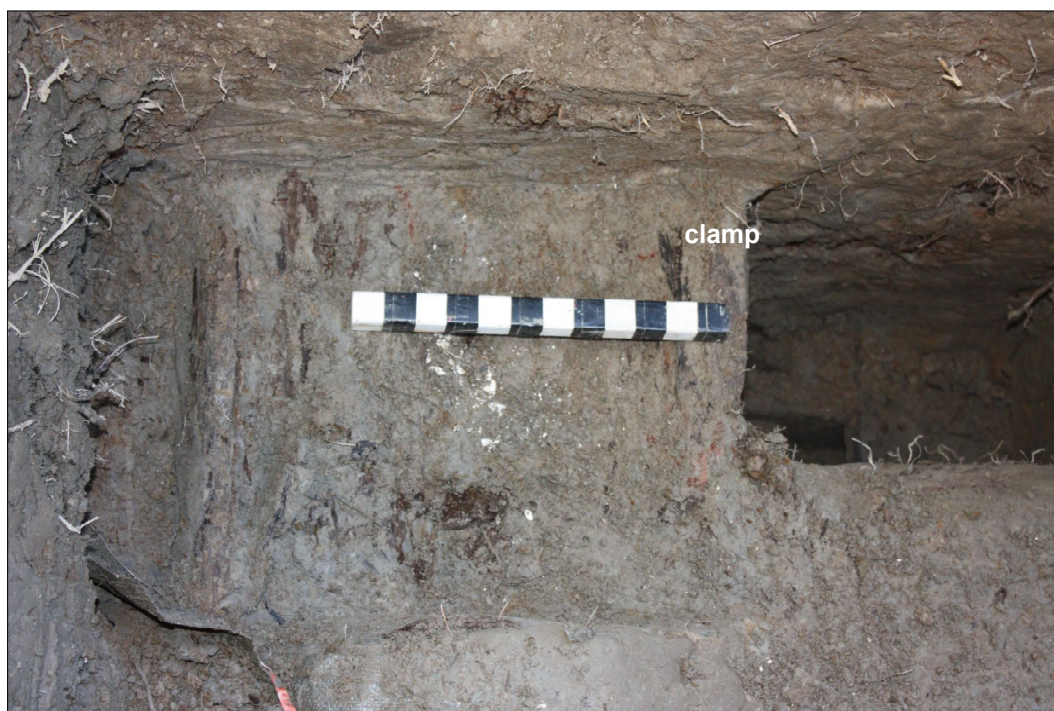
Trench 3 was originally excavated between 24 and 26 October 2010 during high water. MHM re-opened the trench on 30 September 2011 in order to more fully investigate the inner hull structural components that could not be accessed and documented in 2010. A section of decking in Trench 3 did not survive and the area was large enough for MHM to reach the turn of the bilge. The area below the clamp in Trench 3 – that was damaged by the weight of over 100 years of soil pushing down on it – could be cleaned enough for MHM to document the presence of the futtocks, cocked hats, the angle of the turn of the bilge, the chine clamp, and the probable measurement of the wreck's depth of hold. The trench was photographed, drawn, and back-filled.

Trench 3. The deck planking in Trench 3 is damaged or this area represents where a deck structure once stood, which allowed the examination of the inner hull construction attributes.

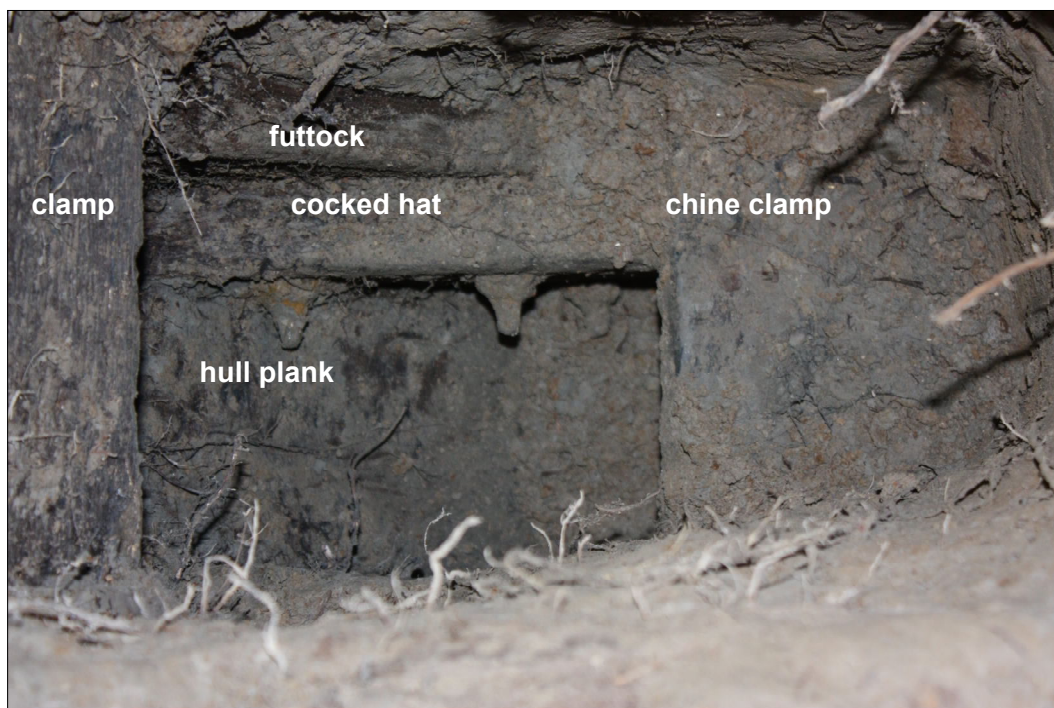
Trench 3. The photograph above is a close-up of the section in the upper right corner of the previous photograph. To the left is the damaged clamp. The two bolts are holding a cocked hat to a futtock and the chine clamp is seen along with the inside of the outer hull. The turn of the bilge is under the chine clamp.

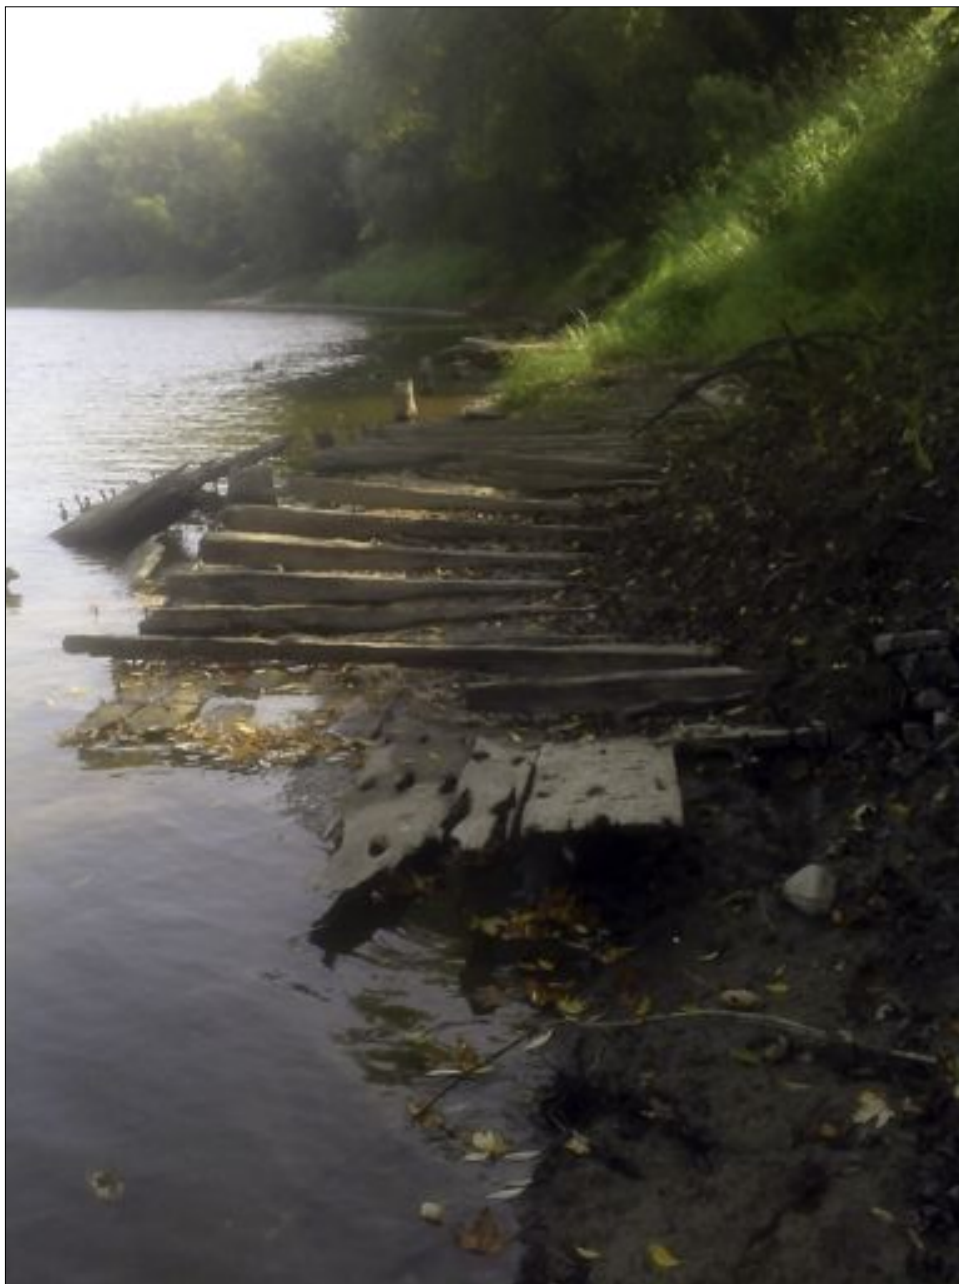
Andy Gibson from her stern during extreme low water conditions in September 2009. From this angle the structural components shown in the image include the outer hull planking, floors, and the bent cylinder timber supporting rods.
